UPGRADING OF EXISTING STRUCTURES, PHASE III, SHELTER DESIGN OPT--ETC(U)

Upgrading of Existing Structures Phase III Shelter Design Options

FINAL REPORT

SCIENTIFIC SERVICE, INC.

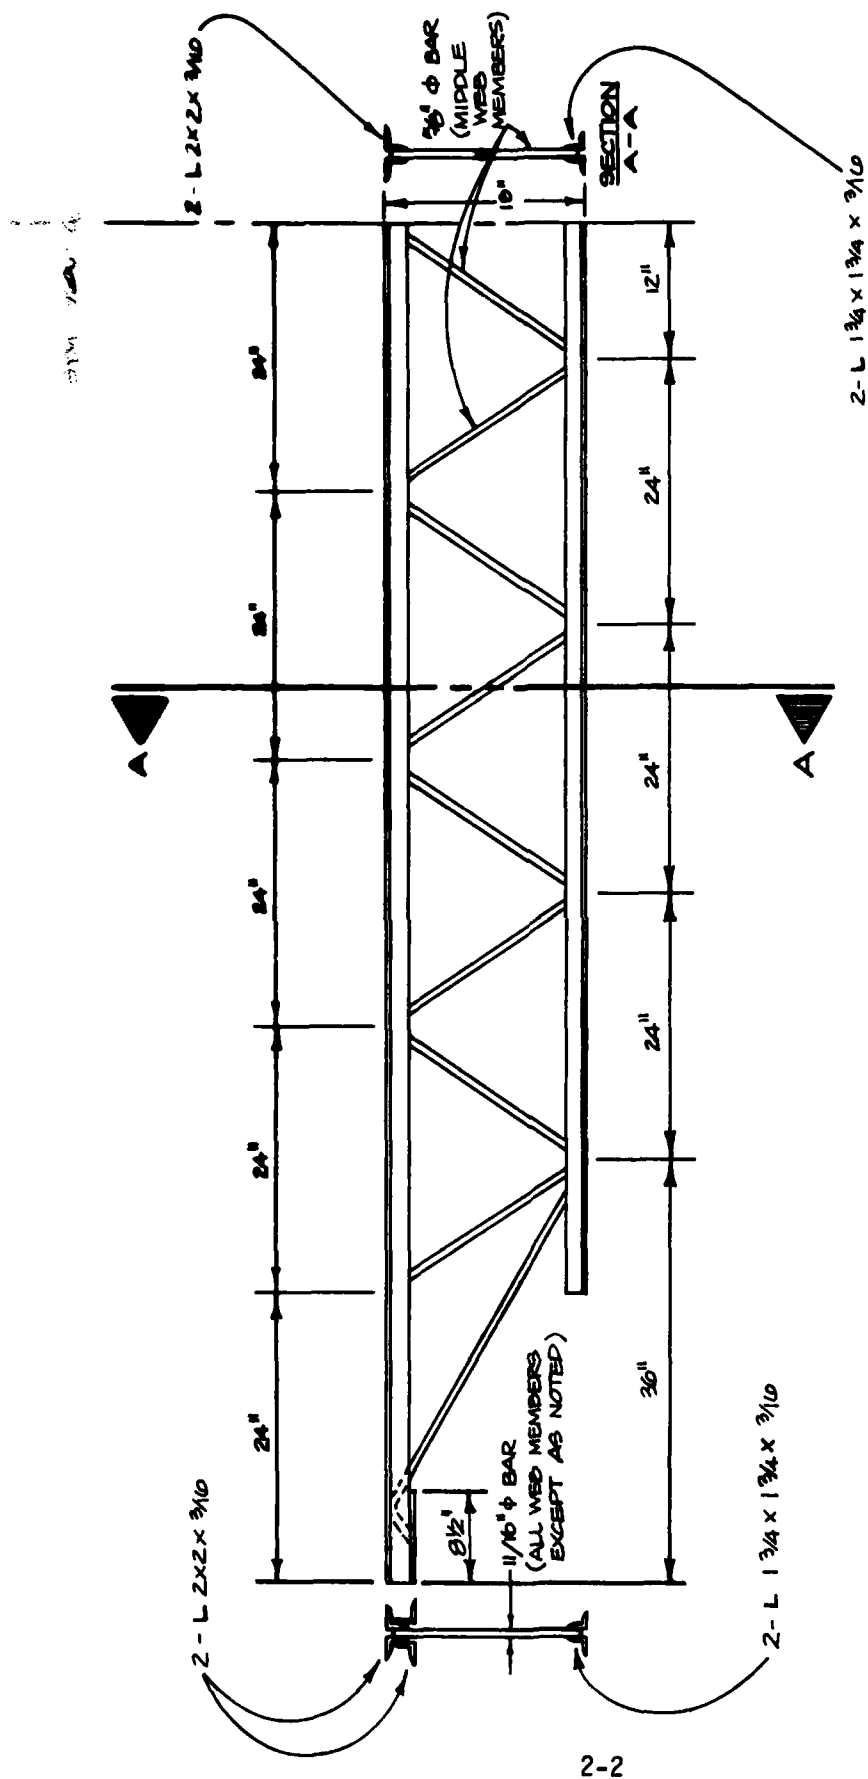
Fig. 2-1. 18H8 Open-Web Steel Joist.

Under normal service conditions, the top chords of open-web steel joists are subjected to axial compression and are restrained laterally by the floor slab or roof deck above. The bottom chords are subjected to axial tension. The web members develop both tension and compression, with compression being the most critical because of the slenderness of the member. The mode of failure for a given joist is a function of the span and loading.

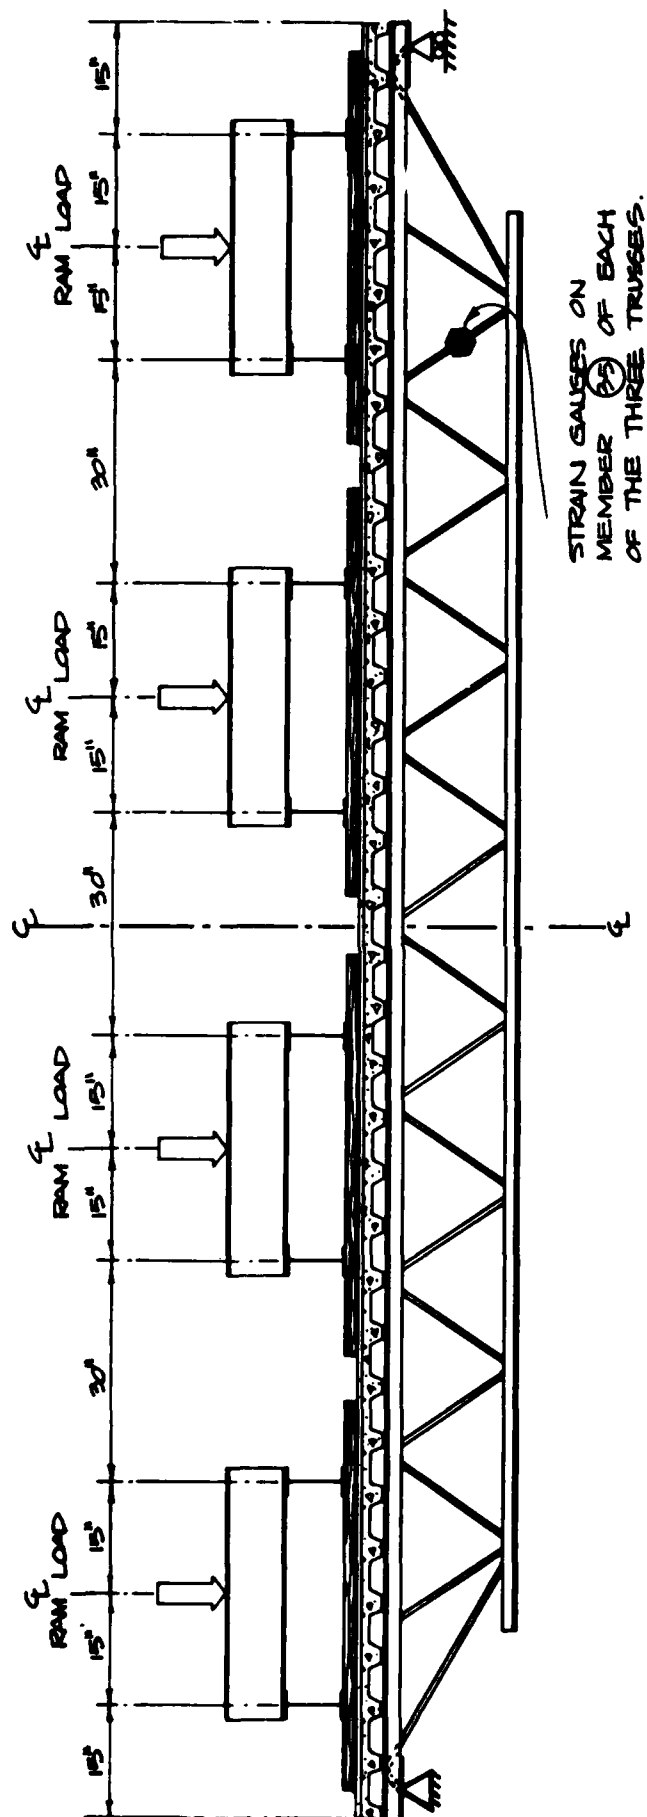
Fig. 2-6. Loading Configuration for Test No. 79-1.

This test was conducted without any shoring or upgrading modification. The test specimen was not loaded to failure, but was tested to obtain load deflection data in the elastic domain. Loading was applied to the test specimen by hydraulic rams at eight locations, spaced equally along the length of the test sample to simulate, as closely as possible, a uniform load. The loading configuration is shown in Figure 2-6.

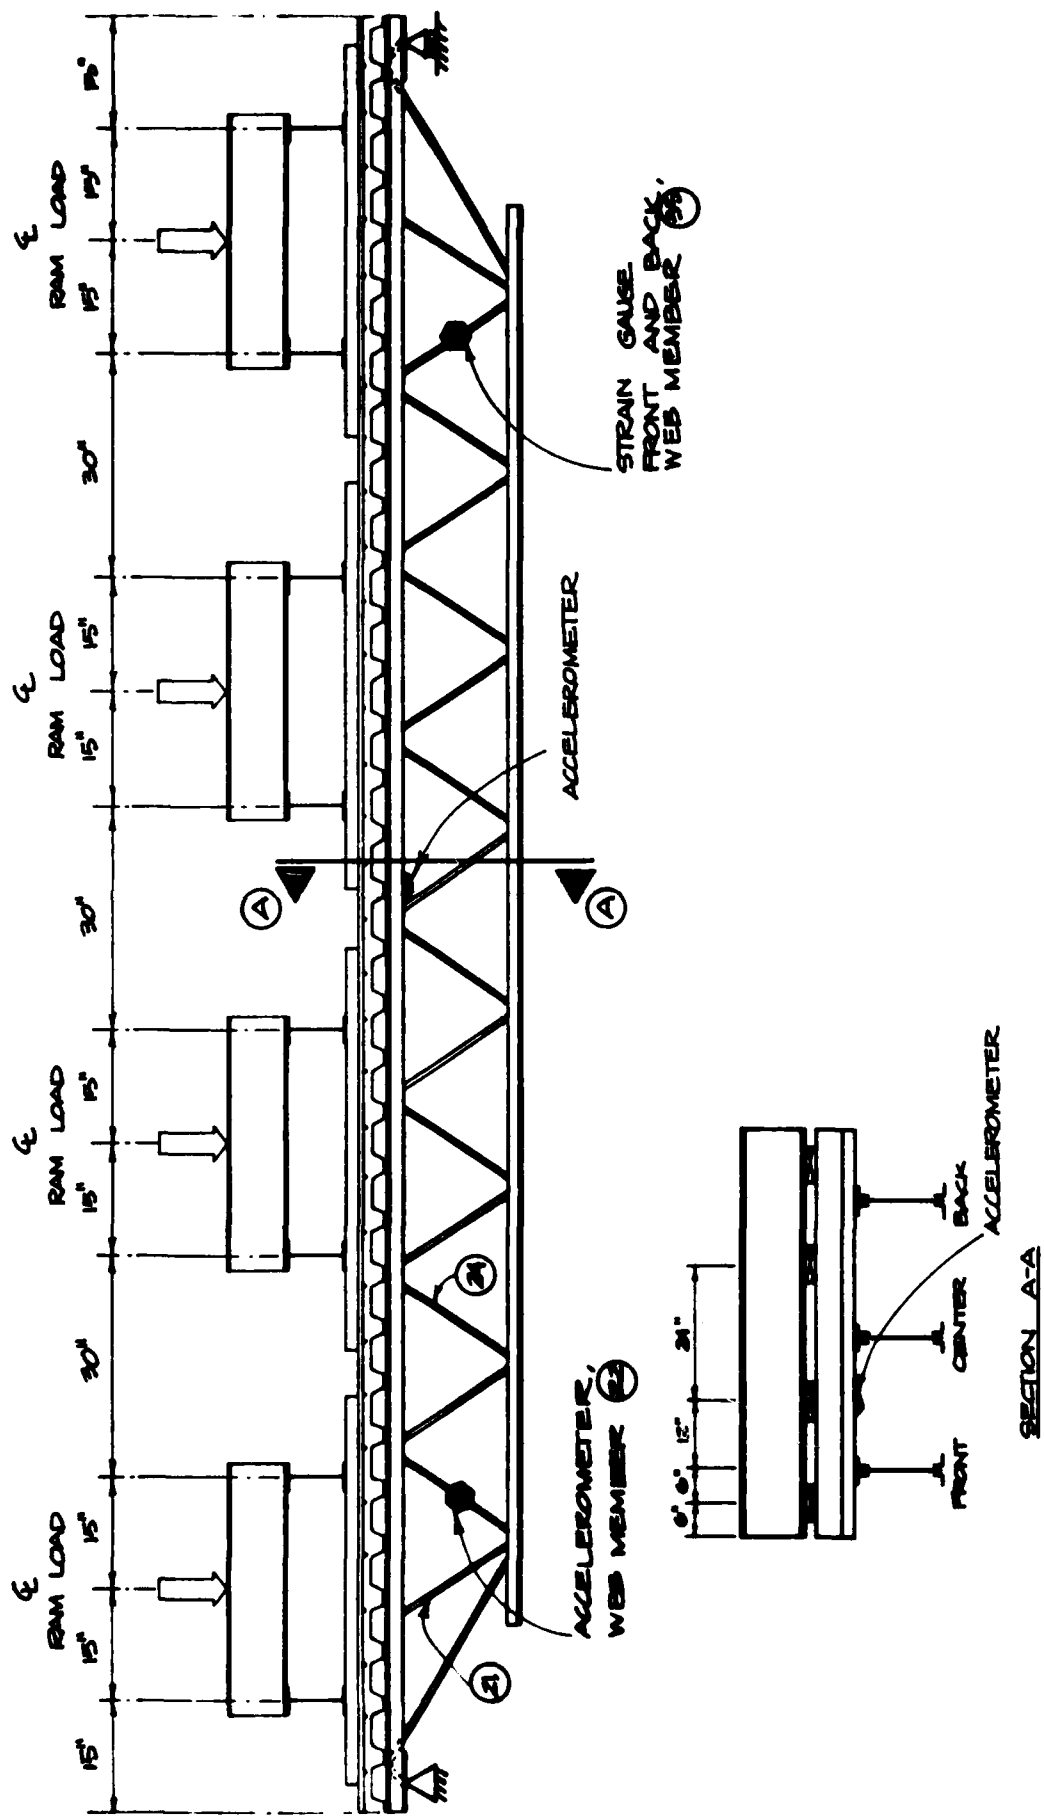
Fig. 2-26. Test Configuration for Test No. 80-1.

Note that the last recorded midspan deflection just prior to failure (1,160 plf/joist) was 0.0625 inches. In comparison, Test No. 79-3 (shoring at midspan) had a midspan deflection of 0.595 inches just prior to failure (1,928 plf/joist).

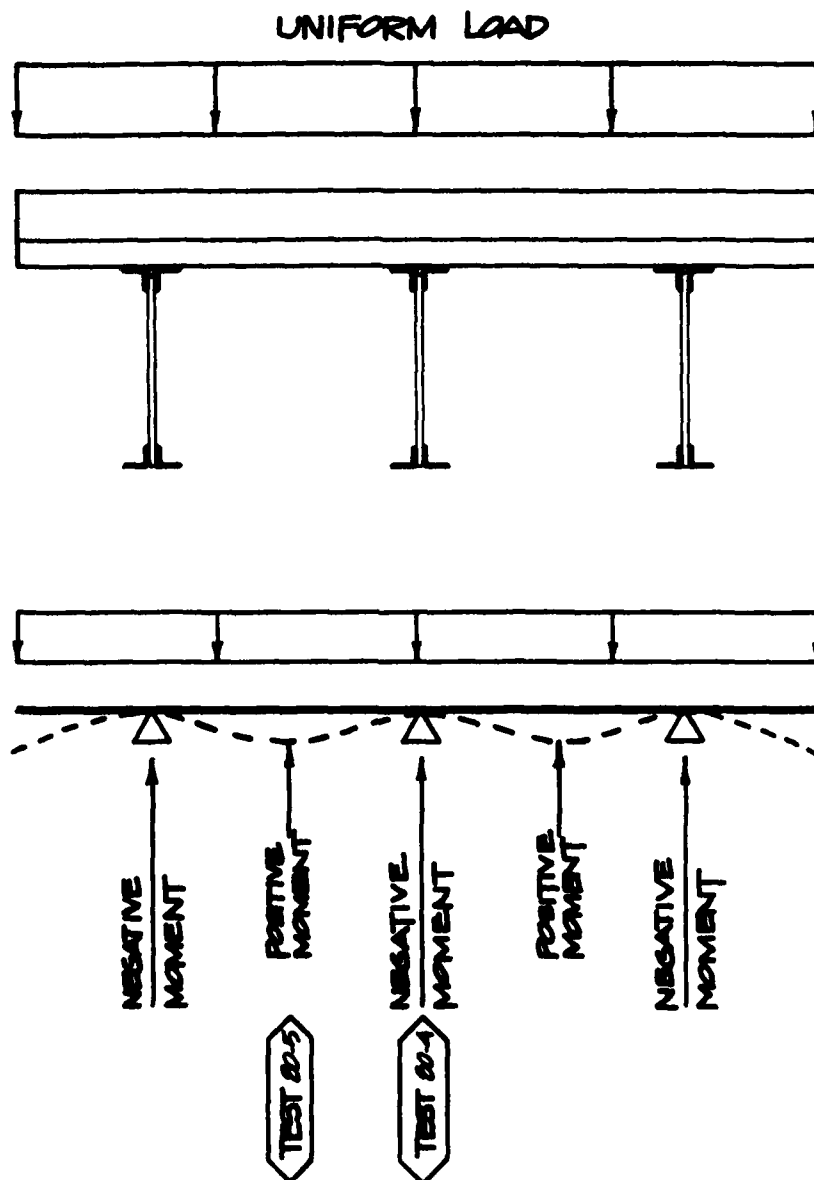
The sketch below shows the applied load in the transverse direction and the regions of positive and negative moment.

Specimen 80-4. — The test configuration and loading arrangement for test specimen 80-4 are shown in Figure 2-37. The objective of this test was to determine the ultimate negative moment capacity (tension on the top and compression on the bottom fibers of the section) of the composite deck (concrete and fluted metal decking).

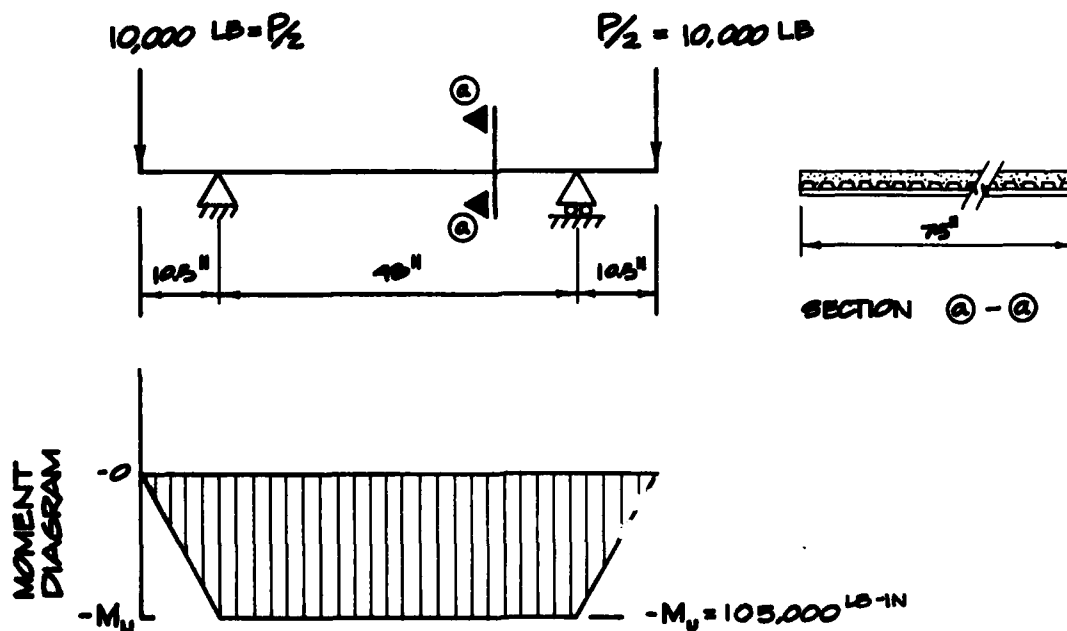
LOAD-MOMENT

The corresponding ultimate negative moment capacity of the decking is:

$$-M_u = 105,000 \text{ lb-in.} = 1400 \text{ lb-in./in.}$$

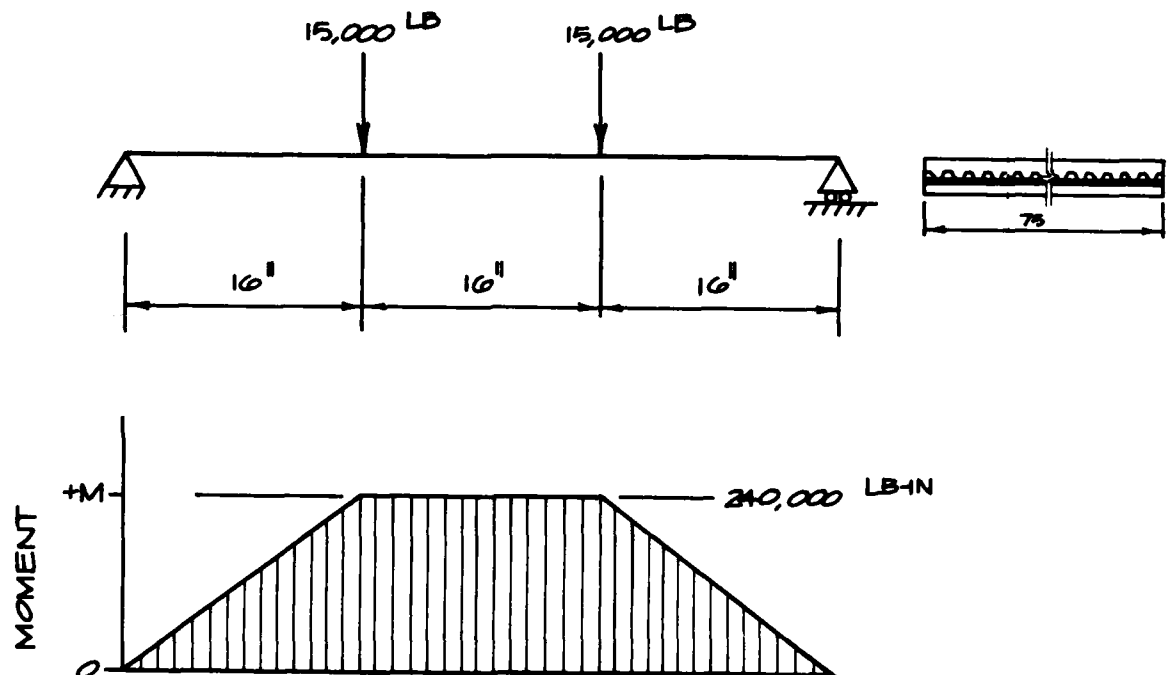
Load was applied in 4,000 lb increments to failure. Ultimate failure occurred at an applied load of 30,000 lb. Below are sketches of the loading and moment diagram at failure.

At 30 kips, the maximum positive moment is

$$M_u = 240 \text{ kip-in.} = 3200 \text{ lb-in./in.}$$

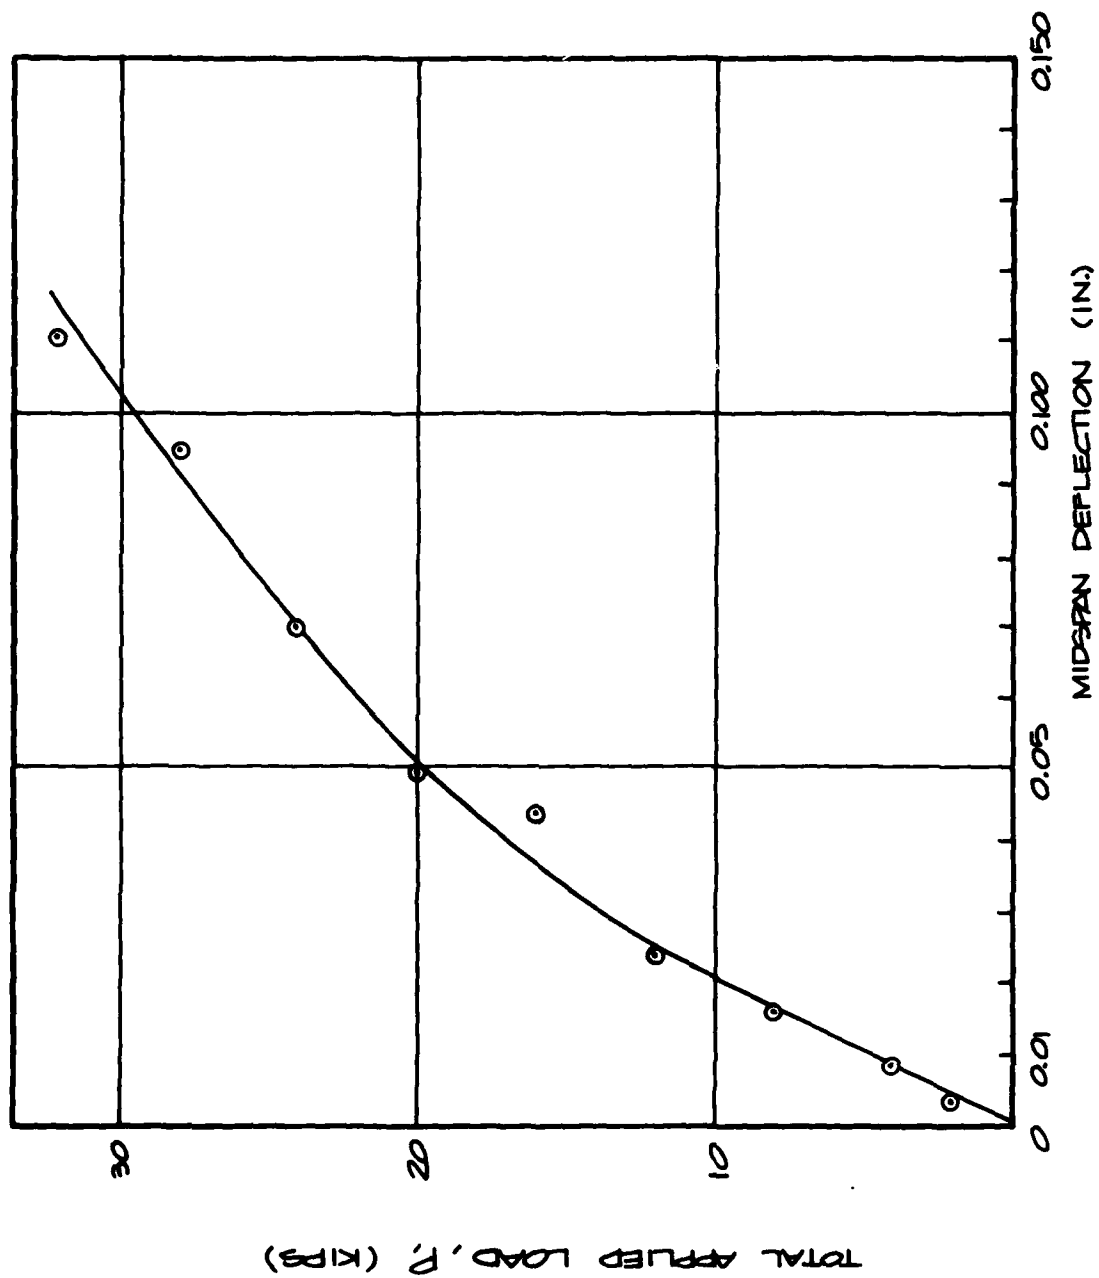
Fig. 2-42. Load vs Deflection for Test No. 80-5.

A plot of load vs deflection for specimen 80-5 is shown in Figure 2-42. Figure 2-43 shows the positive moment flexural crack in the section of the deck under maximum positive moment.

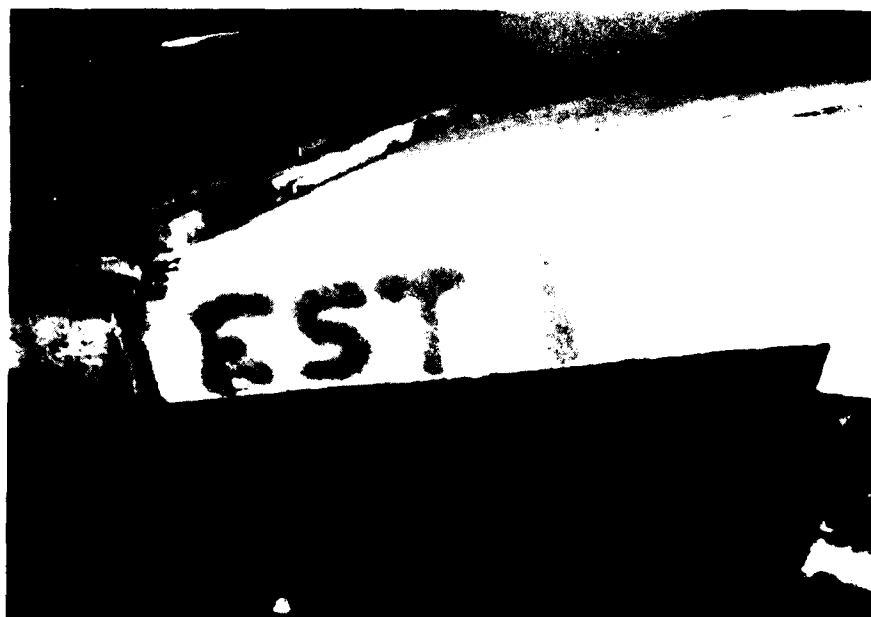
Fig. 3-31. Left and Right Span Failures, Test No. 7.

Figure 3-30 shows the slab before and after test. Figure 3-31 shows the failure near the left support and the right span failure.

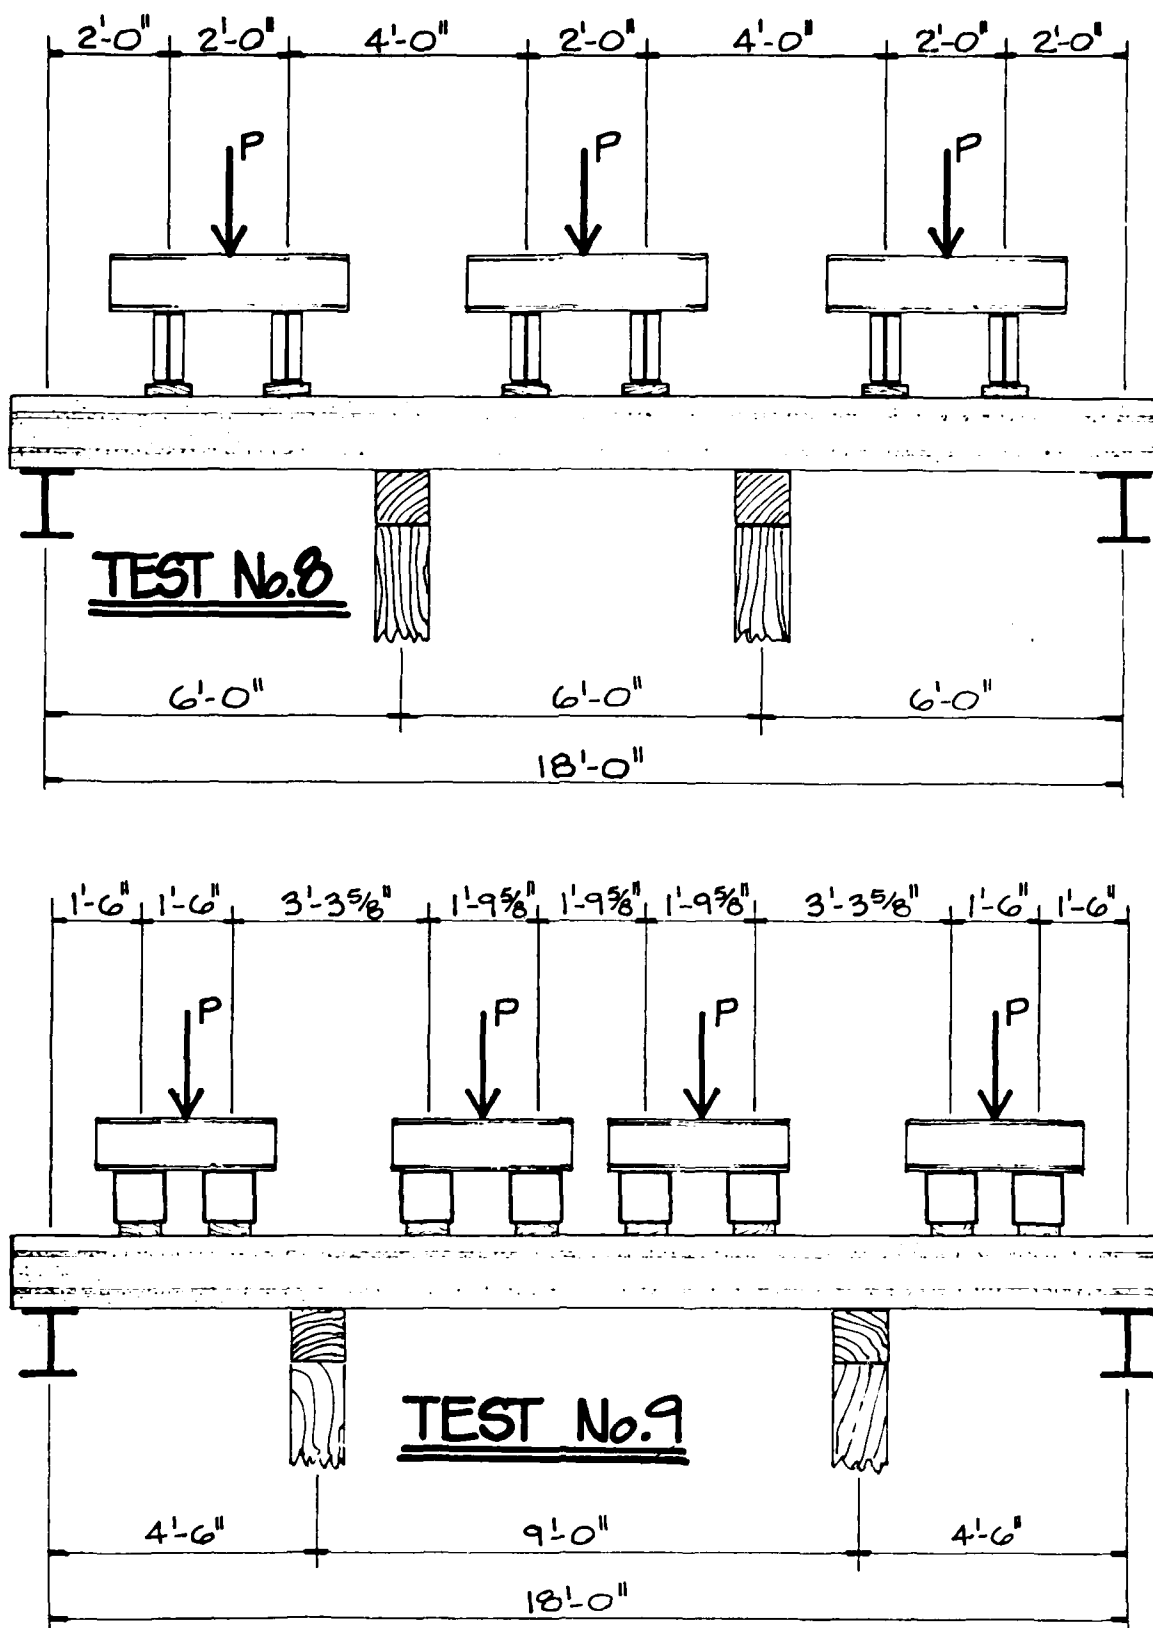
Fig. 3-32. Loading Configuration — Two Shores, 8-inch Slabs, Tests Nos. 8 and 9.

In both tests, the load was applied at a slow rate of 4,000 lb/ram increments and the deflection recorded at each increment.

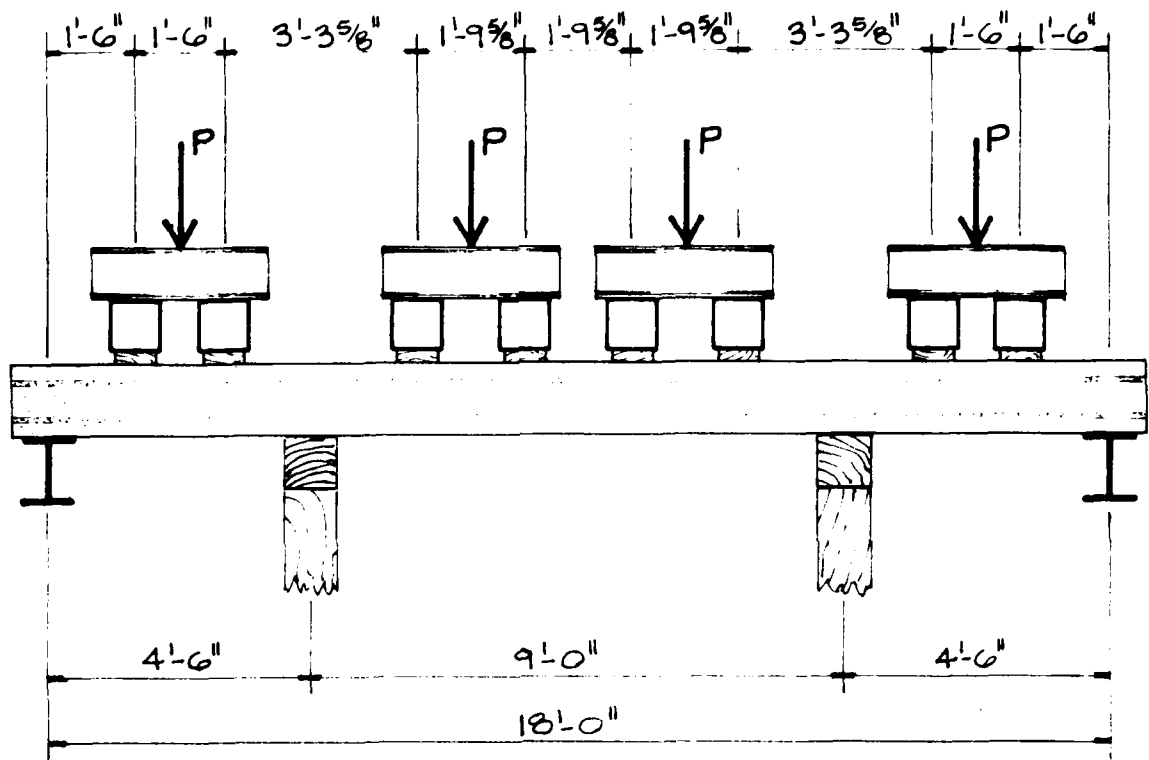
Fig. 3-58. Loading Configuration — Two Shores, 10-inch Slabs, Tests No. 14 and 15.

In both tests, the load was applied at eight locations by four rams, and the vertical deflection was measured midway between each of the supports and over each of the shores. The loads were applied at a slow rate in varying increments of 4,000 to 8,000 lb/ram and the deflection recorded at each increment.

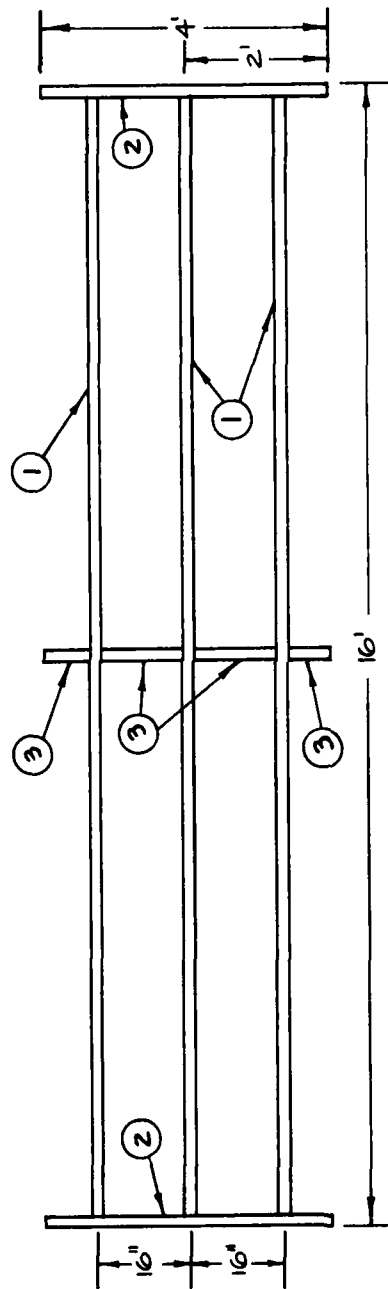
The program consisted of load tests to failure of three identical test assemblies. The assemblies were similar to those tested and reported previously (Refs. 3 and 4), except that deeper joists (2x12's instead of 2x10's) were used. These deeper joists were required because of the increased design live loading. The framing and construction details are shown in Figures 4-1, 4-2, and 4-3.

① 2" x 12" x 15'9" JOIST ON 16" CENTERS

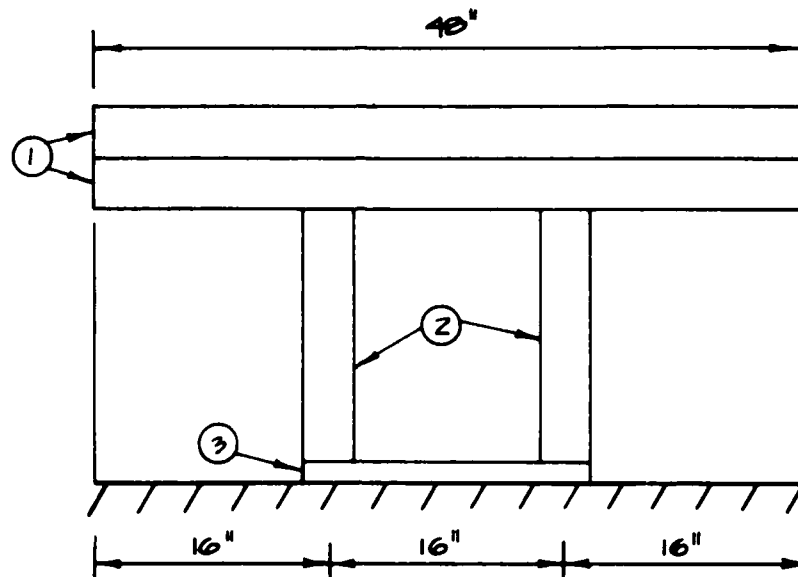
- ① 4" x 4" x 4' NAILED TOGETHER WITH FOUR 8d COMMON NAILS (TOENAILED).
- ② 4" x 4" x 17" NAILED TO THE 4" x 4" x 4' WITH TWO 8d COMMON NAILS EACH (TOENAILED).
- ③ 2" x 12" x 14" NOT NAILED.

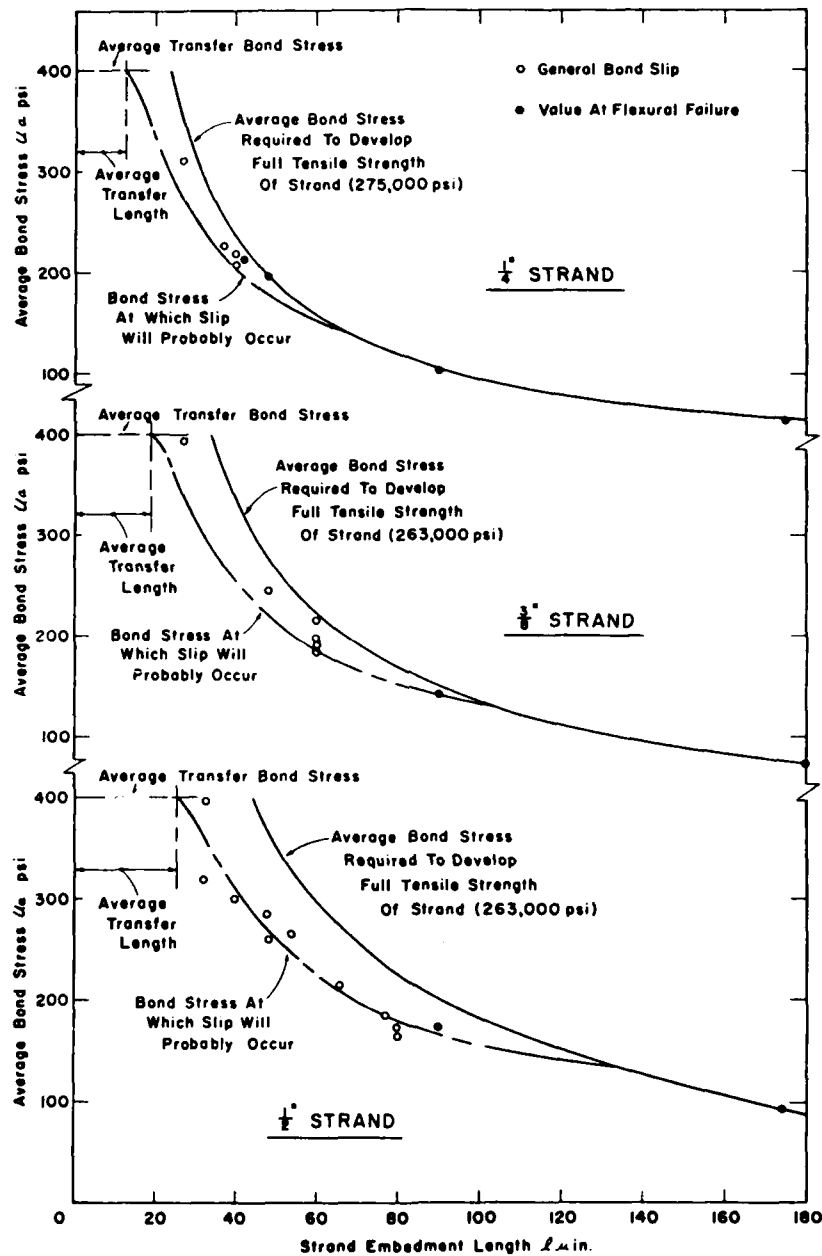
Fig. 5—Relation of average bond stress u_a to strand embedment length

In the end span, shear intensities necessary for shear failure are also large enough to create flexural bond stresses in excess of transfer bond capacity. Hence strand slip and subsequent prestress loss occurs.
